Nigel Grossman Surveying

BUILDING SURVEY

**5 ANYTOWN ROAD
ANYTOWN
LONDON
ABC 123**

14 May 2019

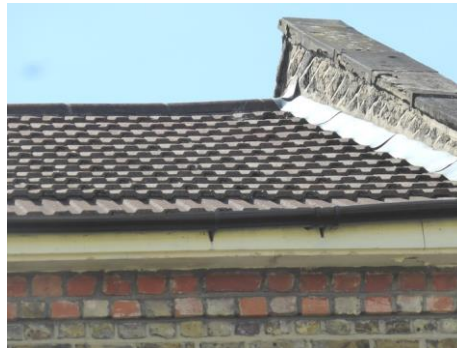
The degree of distortion does not appear to have adversely affected the structural integrity of the roof covering. Where seen the tiling was in generally good condition overall. However we did note some slightly proud tiles, for example on the rear roof slope towards the left hand chimney stack and also to the right hand side immediately below the ridge and adjacent to the right hand parapet. All such dislodged/proud tiles should be reset straightaway to ensure watertightness.

Front roof slope/parapet

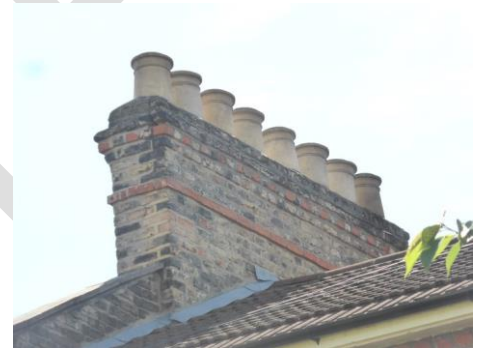
The main stack has been repointed and mortar joints were in generally good condition. However some localised brickwork is affected by frost damage including to the right hand face. This will worsen over time and affected sections must therefore be cut out and replaced straightaway with matching bricks to prevent rainwater penetration internally.

The main stack leans towards Number 7. One possible cause could be removal of chimney breasts in the adjacent property but this could not be verified. The contractor must check the stability of the chimney stack and undertake any necessary repairs to ensure future structural stability. You must also enquire whether chimney breasts have been removed in the adjoining house and if so whether the remaining brickwork has been supported in accordance with current Building Regulations.

Main chimney stack

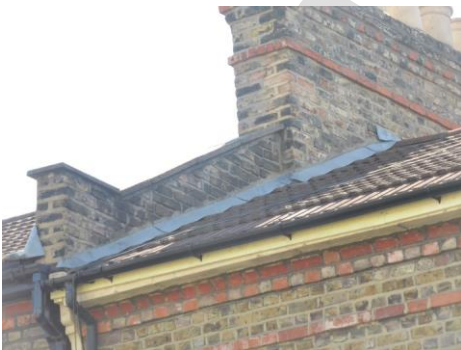
Although the parapets were in generally reasonable condition where seen, some defects were evident. For example we noted slightly worn pointing (mortar joints) to the left hand party wall parapet above the front roof slope, and some laminating concrete copings to the right hand parapet above the same roof slope. We also noted some perished pointing to the kitchen right hand party wall parapet. We should warn that parapets are particularly prone to deterioration and are a common source of damp penetration which can in turn lead to timber defects internally. A competent contractor must carry out urgent repairs to the various parapet areas to ensure watertightness and

LH parapet

This is an urgent repair, and must be remedied as soon as possible after purchase.

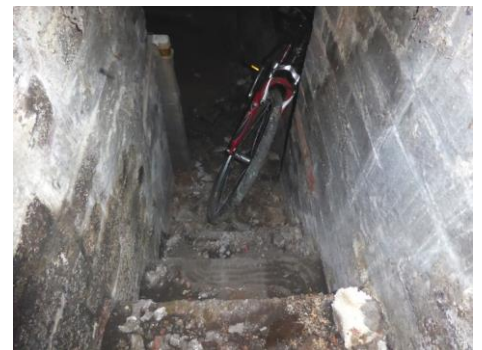
External access to cellar (security risk)

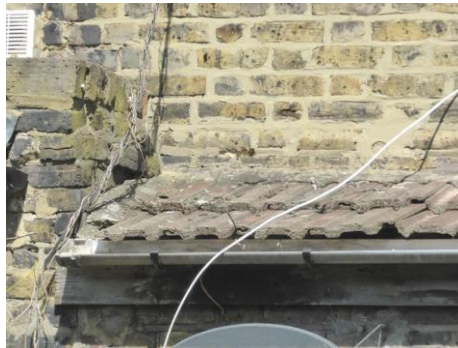
The small, single pitched roof above the rear part of the kitchen has an older, replacement interlocking concrete tile covering. The roof is affected by some distortion, sloping down towards the right hand parapet as discussed previously, and probably connected to the cracking/distortion noted to the back wall of bedroom 3. Although the tiling was in reasonable condition overall having regard for its age there appears to be a missing tile at the bottom right hand corner and this should be reinstated straightaway to prevent rainwater penetration internally. At the same time the cracked, elderly cement perimeter flashings should be replaced with lead to ensure a more watertight joint.

Kitchen roof and defective parapet

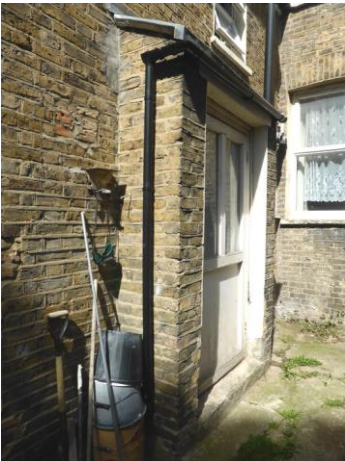
The kitchen side door is of elderly timber single glazed type. The door is warped resulting in a wide gap between it and the surrounding frame. The door also jams when being opened and closed, some of the timber perimeter external beading is missing and the door and surrounding frame are in poor decorative condition. In addition the door is unlikely to afford any significant security and we therefore recommend that the door and surrounding frame are replaced straightaway.

LH flank and kitchen door

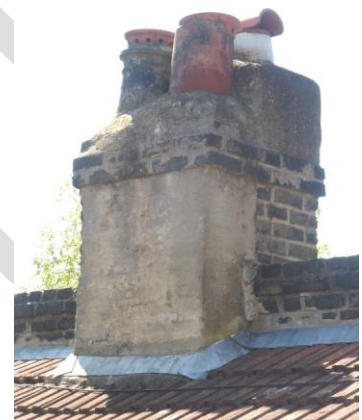
The second stack is rendered. In places the render was cracked and affected sections therefore repair straightaway to prevent rainwater penetration internally. At the time same time localised missing cement flashing requires replacing to prevent internal dampness.

2nd stack

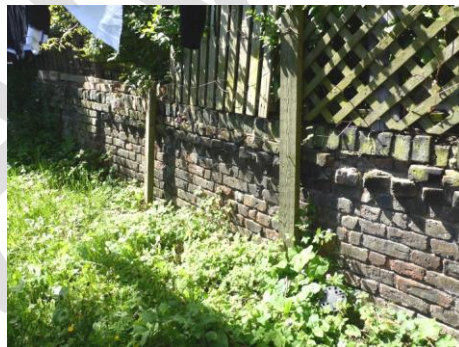
Defective rear garden RH
boundary wall

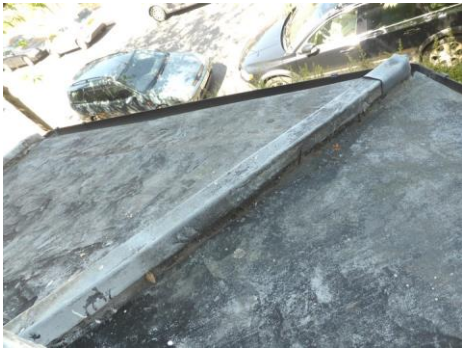
The bay roof above the front reception room is pitched and hipped with an elderly tin or zinc covering and matching flashings. The roof covering appeared to be in generally reasonable condition having regard for its age and no evidence of recent damp staining was detected to the bay ceiling beneath the roof, nor did we detect any dampness to this ceiling when using a moisture meter, although it was not raining at the time of the inspection.

Bay roof

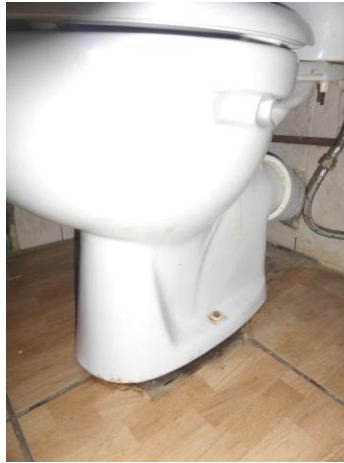
Possible WC leak

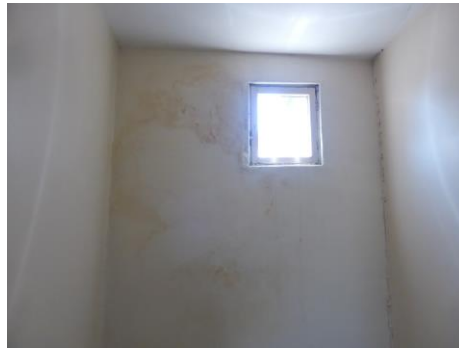
There is an elderly timber single glazed window with basic internal swivel catch located at high level to the back wall of the first floor hall (overlooking the rear addition roof). This window could not be seen externally due to plot restrictions, and only a very limited view was possible whilst standing on our ladder in the first floor hall. Where seen the window is in a poor decorative condition externally and there are likely to be additional defects which we could not see including possible decay, poor perimeter seals, etc. The windows should be examined at close quarters by a competent contractor and all necessary remedial works carried out to prevent rainwater penetration internally and to prevent external decay.

Penetrating damp hall rear wall

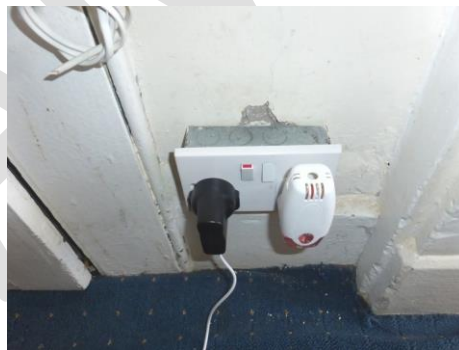
Bedroom 2, hazardous socket

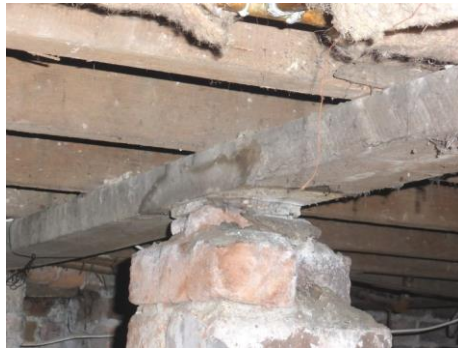
Damp cellar joist above brick pier

As there is always a risk of decay to timbers in proximity to areas of dampness, we also strongly recommend a complete investigation of all adjacent timbers, particularly in the concealed sub-floor area, such as joists, wall plates etc. as well as floorboards for any signs of associated rot. Should any rotted or otherwise defective timbers be present, they must be urgently cut out and replaced, or treated, or as appropriate, under long term guarantee, preferably insurance backed. We recommend that any specialist firms consulted are members of a recognised Trade body such as the PCA.

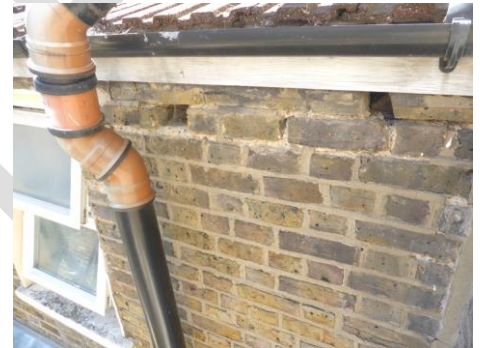
Gaps in rear addition wall

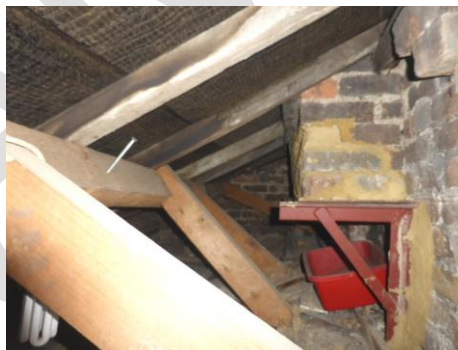
In 6.4 we referred to general undulation of the rear addition tiled roof covering. Viewed from the roof space, the timber roof frame has been subject to significant strengthening work including replacement horizontal purlins and provision of a significant number of diagonal struts to support the purlins. The roof frame appeared to be in good condition although not every length of timber was examined, or indeed accessible, and we have not carried out calculations to verify the structural adequacy of the roof frame.

Rear addition roof space and
gallows brackets
