# Your survey report

**Property address**

Sample Way, XXX XXX

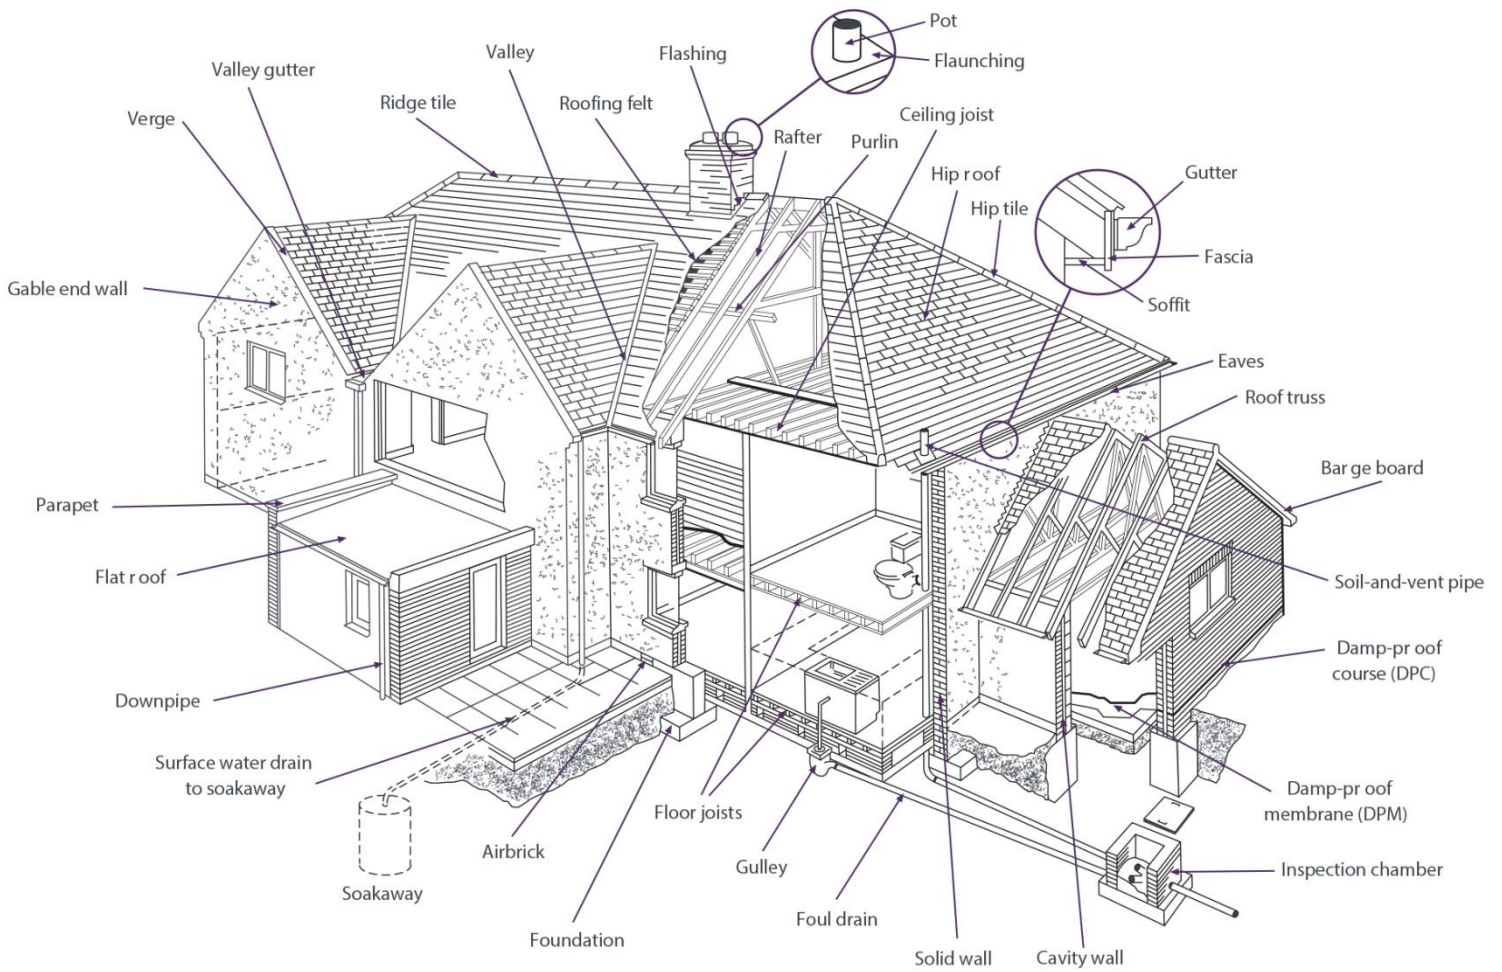
# Typical house diagram

This diagram illustrates where you may find some of the building elements referred to in the report.
